**Accident Investigation Board of Finland
Annual Report 2004**

MISSION OF ACCIDENT INVESTIGATION BOARD

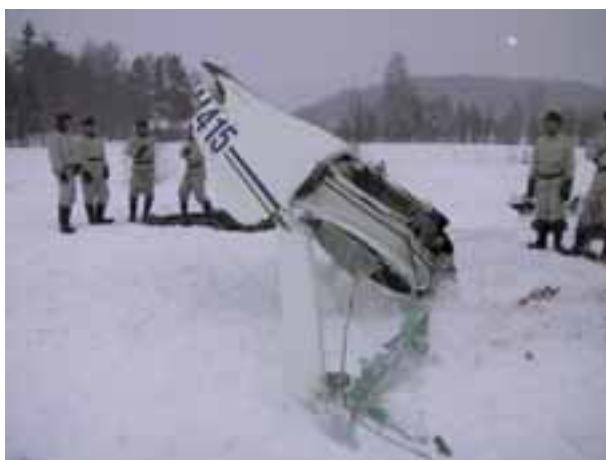
B 1/2004 L

Ultra-light aircraft accident in Hollola on 16 February, 2004

The probable cause of the accident was overweight and center of gravity that was well beyond the aft limit. As a result, the aircraft became unstable. When the horizontal stabilizer was suddenly pulled back, either by a gust or by the pilot unintentionally, the aircraft entered rapidly in a steep nose-up attitude and further inverted. The pilot had not fastened his seatbelts, or had unfastened them at some point, so he fell through the canopy. One reason for the pilot's unfastened seatbelts could be that they were deliberately unfastened in order to reach for the luggage compartment behind the seats. As a result of this kind of movement, the center of gravity would move even further backwards, making the aircraft more unstable. The horizontal movement of the aircraft had been so rapid, that the pilot had no chance to make corrective action. It is also possible, that as the airspeed decreased, the possible corrective action had no longer effect on the movement of the aircraft.

The Investigation Commission made three safety recommendations as a result of the investigation. The Finnish Aeronautical Association is recommended to emphasize the importance of the student's ability to fully understand the contents of their training and that the training is complemented with practical examples and learning is confirmed by examinations. This should be achieved by stressing the matter during teacher's basic and supplementary training. The Finnish Flight Safety Authority (FSA) is recommended to draw their attention to the performance and handling qualities of various ultra-light aircraft types and to define, if necessary, the requirements set for type training. Further, the FSA is recommended to consider bringing the ultra-light pilot's licence requirements up to date and in line with the current aircraft types' requirements and field of use.

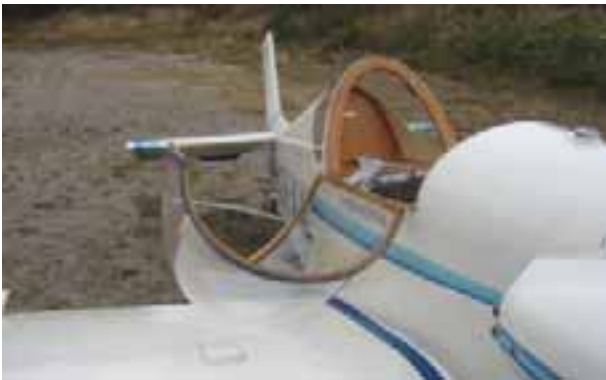
**B 3/2004 L****Aircraft accident in Mäntsälä on 24 August, 2004**

The aircraft had crashed on a vertical angle of 40°–50° and banked to the right. The crash trace heading was 044°. The accident site co-ordinates were 60°36,881 N 025°22,121 E (WGS 84). The investigation of the propeller revealed that the engine had been running the whole time. All the outer parts of the aircraft were found, so the aircraft had not broken into pieces in the air. The frame of the cabin hood was apart from the cabin frame, in which the hood lock lever was attached. The lock was open, the hinges were unbroken, but the limiter rope was broken. The spring belonging to the lock lever was missing. The acrylic hood had gone into pieces, but some pieces were still attached to the hood frame. There were lots of pieces of the hood along the crash trail. Some of the pieces were found also approximately 700 meters east-south-east from the accident site. A conclusion was made that the hood had opened in the air and hit the wing. The dispersion of the aircraft and the crash traces on ground proved that the collision speed was high. It was also possible to draw the conclusion that the aircraft had not been in a spin. The aircraft was not overweight. The centre of gravity was within the limits.

The probable cause of the accident is that the lock lever of the hood had during the flight accidentally opened. The side-hinged hood had immediately opened and hit the right wing of the aircraft, and the hood partially broke. On the basis of the finding place of the hood pieces, it is obvious that the hood had accidentally opened just before the crash dive. The aerodynamic drag of the large hood swung the nose of the aircraft to the right. Simultaneously the aircraft rolled rapidly to the right and the nose went into a steep dive. All happened so swiftly that the pilot lost the possibility to upright the aircraft because of low altitude.

The investigation commission presented no safety recommendations.

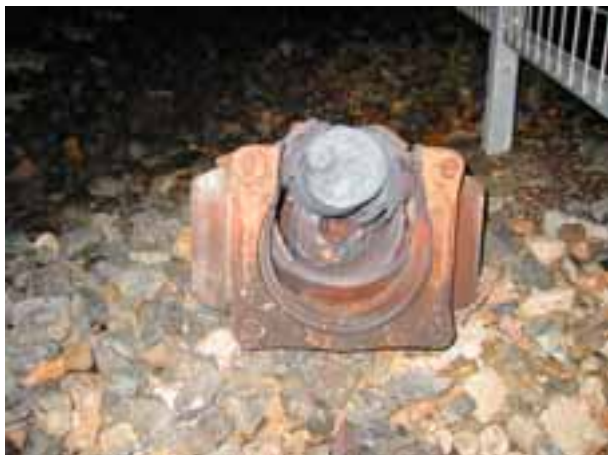
C 5/2003 R

Last car of freight train displaying bearing damage and derailling in Lahti on 28 May, 2003

In terms of hot-box detectors, the Accident Investigation Board notes a favourable development and progress and suggests that their generalization take place at an even faster pace than currently.

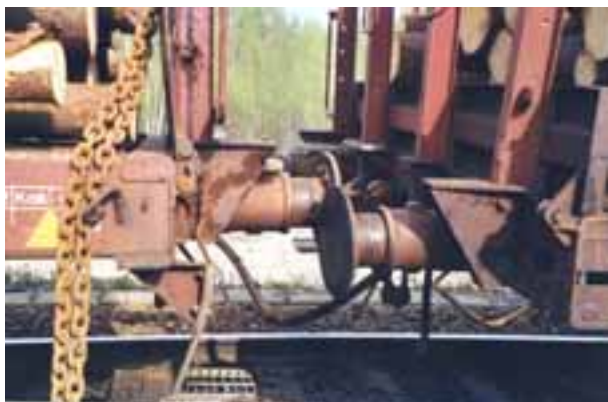
C 3/2004 R

Freight train car derailling at Joensuu on 8 May, 2004

To prevent corresponding incidents in the future, the Accident Investigation Board of Finland recommends that in all work site plans, condition limits be specified for unfinished track work sites that are temporarily opened for traffic. The condition limits would unambiguously define the circumstances where the condition of the track no longer permits its utilization as due to a risk of generation of a heat curve or as due to other changes in the track condition.

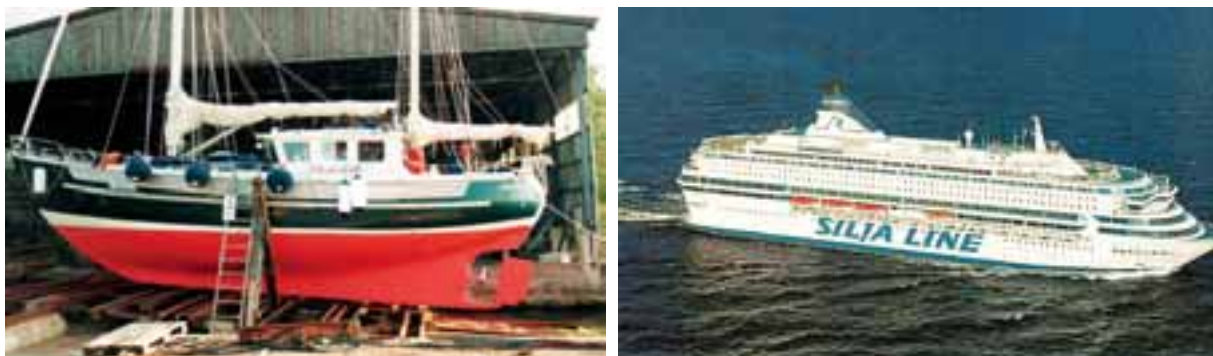
ms SILJA EUROPA–sailing yacht FLANÖR, collision in Åland archipelago on 20 August, 1997

Finnish passenger-car ferry ms SILJA EUROPA and German sailing yacht FLANÖR collided on 20.8.1997 at about 14.15 close to the fairway edge mark Rågrund in Åland archipelago. There was dense fog at the time of collision, visibility being about 200 meters.

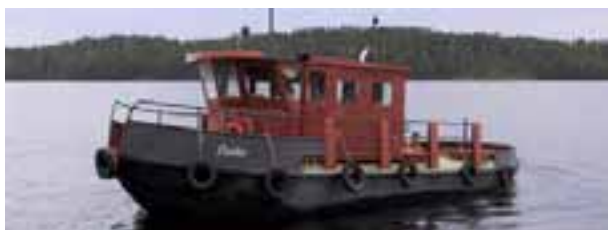
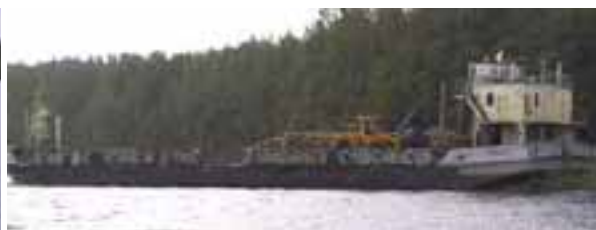
Push barge PUSKU and PÖLLI 7, grounding in Savonlinna on 11 July, 2002

Tug boat PUSKU was pushing a combination of two barges connected to each other side by side, through the fairway of Kyrönsalmi in Savonlinna on 11.7.2002. The bigger barge called PÖLLI 7 carried mainly birch logs and the smaller barge a timber - handling machine. At the castle Olavinlinna when manoeuvring through the strait of Linnasalmi, the bow of the barge PÖLLI 7 hit the guide fitted on the shore rock of the isle of Linnasaari. As a consequence, the combination turned to the right and drifted into the shallows of the isle of Tallisaari and grounded. The barge PÖLLI 7 got a leakage and a list. A half of logs rolled in the stream and the timber handling machine was

The accident resulted from the steering of the too wide tug-barge combination having poor manoeuvring capabilities through a difficult navigable strait. Moreover, the crew had manoeuvred this type of combination on a few occasions only and the routine to do it had not accumulated.
