Tail strike during take-off

Boeing 737-800, registration PH-HZB,
Rotterdam Airport, January 12th 2003

The Hague, November 2006, project number 2003004

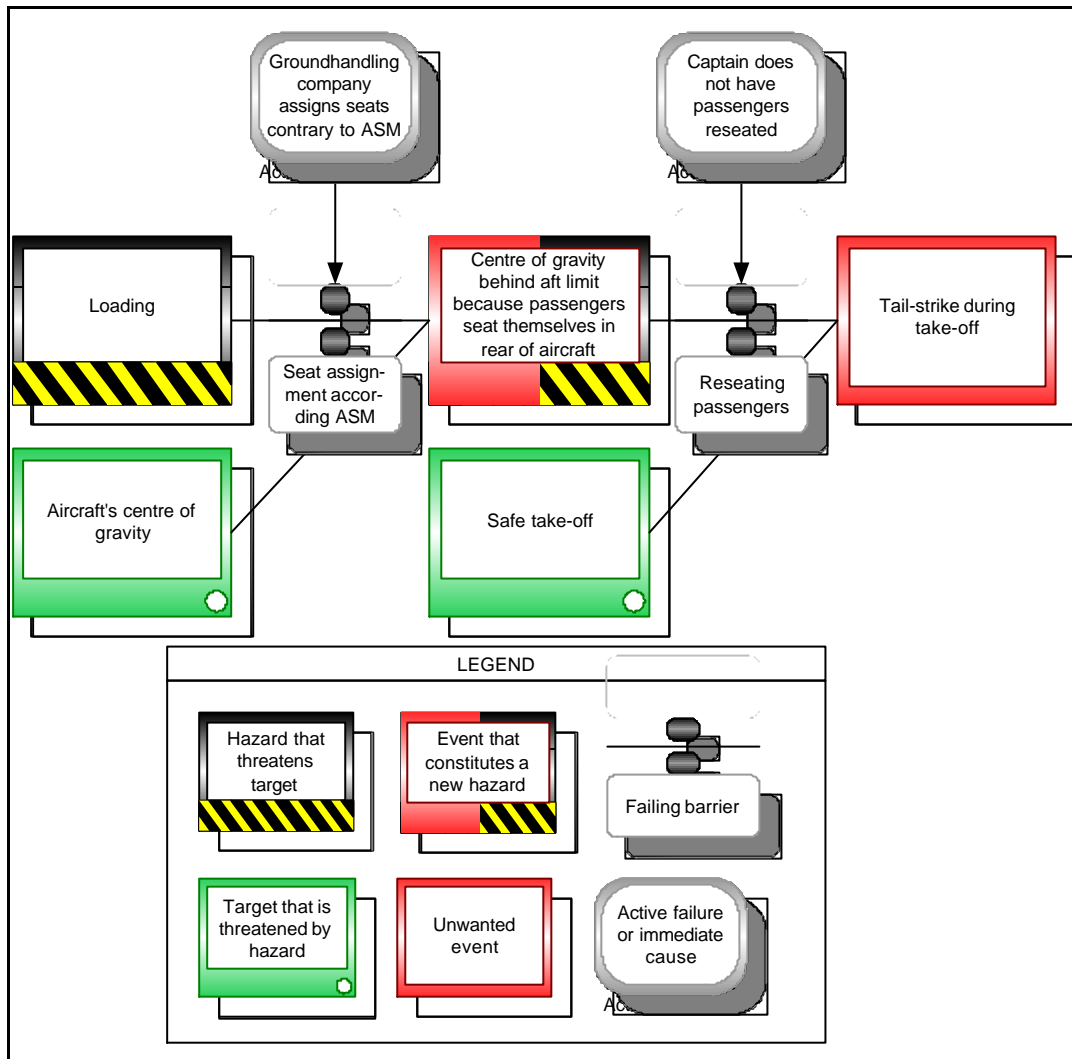
Figure 1: Simplified diagram of the Tripod analysis of the "Tail strike" of the Boeing 737-800 during take-off at Rotterdam airport on January 12th 2003

- Aviapartner did not assign the seats to the passengers in accordance with the passenger distribution table in ASM. As a result, passengers seated themselves in the rear of the cabin;
- Consequently, the aircraft's centre of gravity was situated behind the applicable aft limit. This deviation was not rectified by reseating the passengers;
- Because of this, the aircraft pitched nose-up just after take-off thrust had been selected. Subsequently, this movement stopped when the aft fuselage and the tailskid assembly contacted the runway (i.e., tail strike during take-off).

For both barriers, the present report describes how and why these "controls" failed. In this respect, and in agreement with Tripod Beta, the report distinguishes between preconditions and latent failures at the organisational level. To uphold the readability of the diagram the preconditions and latent failures are not included in figure 1, but are presented separately in table 11.
