INCIDENT

Aircraft Type and Registration:	Airbus A320, EI-DIJ	
No & Type of Engines:	2 CFM 56-3A3 turbofan engines	
Year of Manufacture:	1992	
Date & Time (UTC):	29 March 2006 at 1330 hrs	
Location:	Ballykelly, County Londonderry, Northern Ireland	
Type of Flight:	Public Transport (Passenger)	
Persons on Board:	Crew - 6	Passengers - 39
Injuries:	Crew - None	Passengers - None
Nature of Damage:	None	
Commander's Licence:	Airline Transport Pilot's Licence	
Commander's Age:	57 years	
Commander's Flying Experience:	14,000 hours (of which 1,800 hrs were on type) Last 90 days - 69 hours Last 28 days - 69 hours	
Information Source:	AAIB Field Investigation

Synopsis

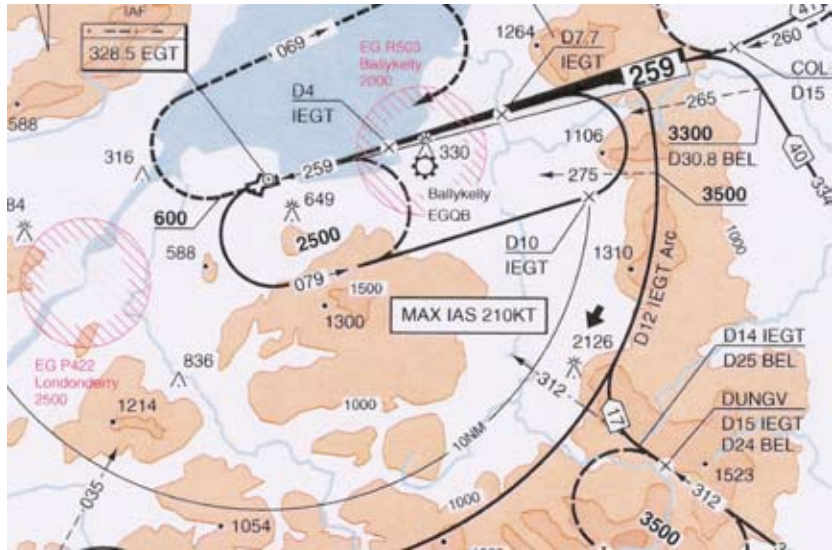
Figure 4

The operating company had provided the operating crew with airfield charts for LDY that had been published by a commercial provider, Figure 4. For three days prior to the incident flight, the commander tried in vain to obtain a copy of the LDY airfield charts, through the LPL operations office and another commercial provider. This was to be fully prepared for the flight into this limiting airfield. However, he did obtain a copy of these charts the day after the incident and stated that, had he seen these previously, he would have been fully aware of the existence of BKY and would not have landed there. This was due to the different presentation of the data, in particular, the manner in which BKL was

Section of approach chart used by the crew of EI-DIJ

depicted, Figure 5. He had been issued with a ‘brief’ by his company prior to operating the flight, but this contained no reference to BKL.
