## Uncovering the policy factor in accidents

This analysis by a prominent accident investigator shows that managerial policy - not "crew error" - most often triggers airline tragedies.

By Gerrard M. Bruggink

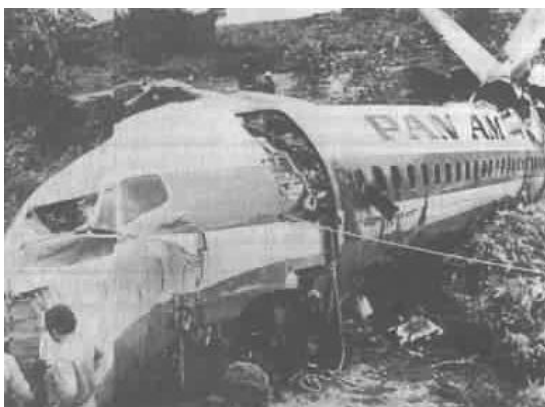
| 6-PanAm | 4/23/74 | Bali | 707 | Approach | 107 | 107 | Crew | |

The aircraft, named "Clipper Climax", crashed into a mountain while preparing for a runway 09 approach to Denpasar after a 4h20m flight from Hong Kong.

PROBABLE CAUSE: "The premature execution of a right-hand turn to join the 263 degrees outbound track which was based on the indication given by only one of the ADFs while the other one was still in steady condition".
