**Accident Investigation Board of Finland
Annual Report 2004**

MISSION OF ACCIDENT INVESTIGATION BOARD

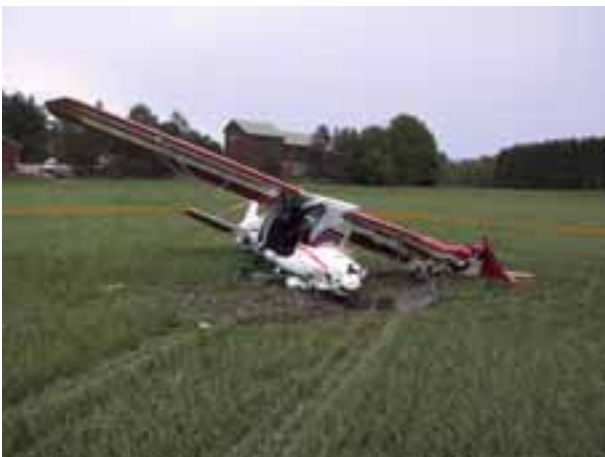
C 7/2003 L

**Ultra-light aircraft accident in Kirkkonummi
on 11 June, 2003**

The investigators found out that the conditions were against a successful take off. The take off direction was uphill and with tailwind, the aircraft was overweight, the field was uneven when compared to the aircraft wheel size, the pilot used full trailing edge flap setting and the engine was likely not producing maximum power due to an earlier impact damage. The cause of the accident was the decision of the pilot to begin the take off from the field under the unfavourable conditions.

The investigators recommended that the Flight Safety Authority would pay attention to the safety belt mounting of the aircraft. The investigators also recommended that the Flight Safety Authority would require all ultralight flight manuals to contain the measured air speed calibration tables.

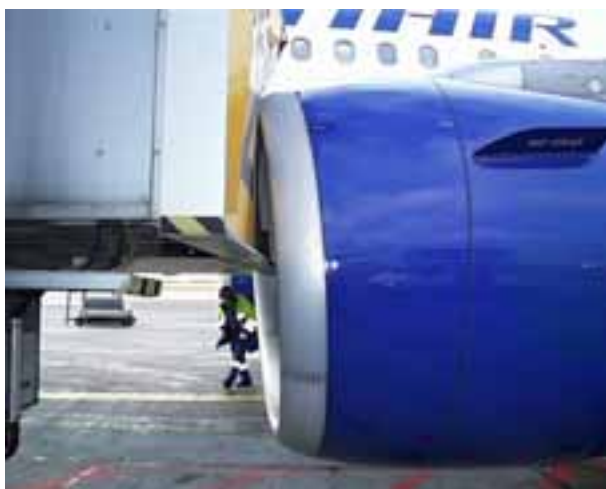
C 10/2003 L

Taxiing incident at Helsinki-Vantaa airport on 6 December, 2003

The passenger bridge had extended to its maximum length, beyond the correct holding position, because of a malfunction in the automatic control system. Contributing factors to the incident were: 1) Double standards had developed in the passenger bridge operation, as well as for handling any faults and malfunctions with the passenger bridges. One procedure was in accordance with official training, and another was an established practice in daily operations. 2) There were shortcomings in the bridge operators' training, operating instructions, and in the monitoring of faults and malfunctions. 3) The marshallers, who carried out malfunction analyses and made decisions about taking a passenger bridge back into service after a malfunction, had insufficient training for handling these malfunctions and identifying any safety risks. 4) The responsible organisations had not audited the operating procedures, instructions and practices for bridge 24. 5) The persons in charge had differing views about the technical characteristics and driving practices of bridge 24.

The investigation commission gave the following safety recommendations: 1) CAA Finland should develop an indicator system for monitoring the position of passenger bridges, based on the APIS system. 2) CAA Finland should examine any prospects for improving technical reliability of the passenger bridge drive system, so that position detection would remain under control despite any fault or malfunction. 3) Helsinki-Vantaa airport should update the operating instructions for bridge 24 and make them constantly available to personnel. Moreover, bridge operators should be provided with a checklist for quick revision of the driving procedures, including safety instructions for the gate in question. 4) Helsinki-Vantaa airport should develop a procedure for collecting any technical failures and operational problems of passenger bridges into a follow-up file, and analysing them at regular intervals. Bridge operations should also be included in internal auditing. 5) Helsinki-Vantaa airport should provide sufficient training for technical support personnel on managing any malfunctions of passenger bridges. 6) Finnair Ltd. should ensure that gate officials are assigned to bridge 24 driving duty in good time.

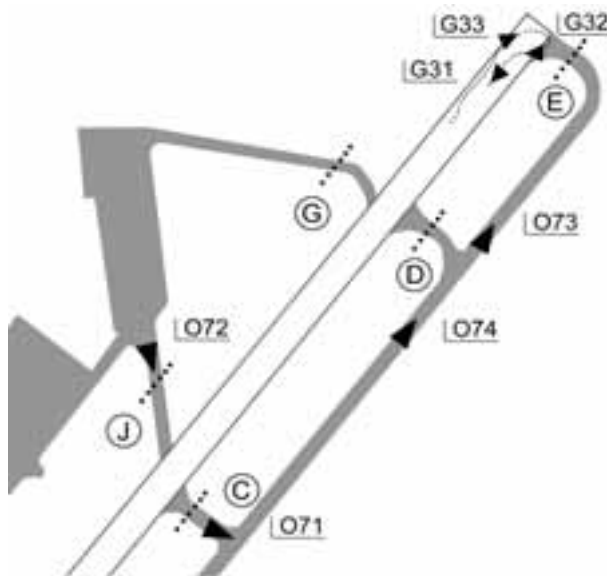
C 1/2004 L

Aircraft incident between a training fighter taking off and a taxiing over the runway at Rovaniemi airport on 14 January, 2004

It was slowly snowing at Rovaniemi airport at the time of incident. The sun had set at 14.26 o'clock and there was low cloud. It was dusk and instrument meteorological conditions prevailed. Military aircraft used the whole runway length for take off because the runway was slippery. The tower controller had cleared a Hawk formation G31 (three aircraft) to taxi from holding position Golf via runway 03 to line up runway 21. At the same time O71 (two F-18) were cleared to taxi to holding position Juliet and over runway 21 to holding position Echo. The controller assumed G31 would be ready for take off when the first F-18 had crossed the runway and he ordered the second F-18 to hold at Juliet. After this G31 was cleared for take off. They took off one by one. The controller followed that O72 stops at the holding position Juliet. At the same time he gave route clearances to the aircraft departing next and control zone traffic information to the radar controller. The controller did not count the number of Hawks taking off but instead followed them "from the corner of his eye". He looked at the runway to see if all the Hawks had taken off. The runway seemed to be empty and accordingly the controller gave O72 clearance to taxi across the runway. When O72 was taxiing across the runway, the third Hawk G33 was starting its take off roll. The pilot of G33 noticed the F-18 taxiing in front of him and aborted the take off. The controller simultaneously noticed the situation and ordered G33 to stop. Also the pilot of O72 noticed the approaching Hawk and accelerated taxiing to hurry over the runway. The filament of the taxi/approach light of last Hawk, G33, had been burned which impaired its visibility under the prevailing conditions.

The cause of the incident was the controller giving O72 the clearance to taxi across the runway without securing that all Hawks had already taken off. Contributing factors were, that the visual limitation to see with eyesight only a dark aircraft against a dark background, especially without an operating taxi/approach light and that the pilot did not inform tower that he will be late for take off.

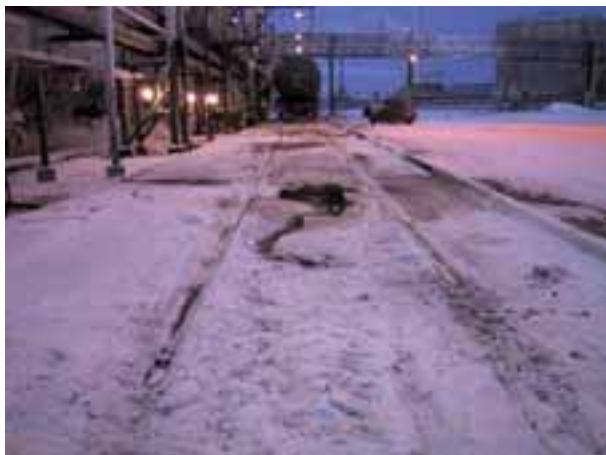
C 1/2003 R

Three tank wagons derailling at Hamina port on 3 January, 2003

On January 3, 2003 at 19.15 hours, three empty Russian tank wagons derailed at Hamina port, Finland, immediately upon leaving their unloading site. The wagons were designed for carrying of heavy fuel oil. The incident caused no damage to the track or the rolling stock.

In fact steaming had been operated on the unloading site, and the resulting condensation water had frozen on the channel rail construction so as to cover the rail channels and hence cause the wagon to derail.

In order to prevent corresponding incidents in the future, the Accident Investigation Board of Finland recommends that no channel rail structures be adopted in tracks on unloading sites where steaming is implemented in the unloading operations.

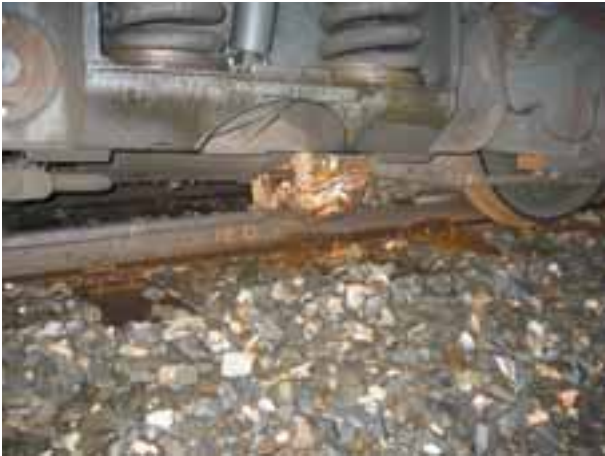
C 3/2003 R

Wheelset of freight train locomotive, derailed at Koskenkorva station on 30 March, 2003

On Sunday March 30, 2003, at 17.15 hrs, the rear wheelset of the locomotive of a freight train derailed at Koskenkorva station when the train ran into a log of birch wood lying lengthwise between the tracks. As a result of the incident, the Dv12 dieselhydraulic locomotive in question, two wooden decks of level-crossing, and track and safety installations and track equipment over about 170 meters were damaged. No personal injury was generated by the incident. The resulting total costs amounted to about € 7,900.

The direct cause of the incident was the locomotive bumping into the birch-wood log lying between the tracks. As a factor contributing to the generation of the incident, the engine driver failed to brake though he perceived the log well before the bumping into it. He did not even brake when the log hit the locomotive.

In order to prevent corresponding incidents in the future, the Accident Investigation Board of Finland recommends that the person responsible for the checking of the travel condition of the train, pay more attention to an appropriate loading of the train and whenever necessary, tie the load, before giving the train a departure permission.

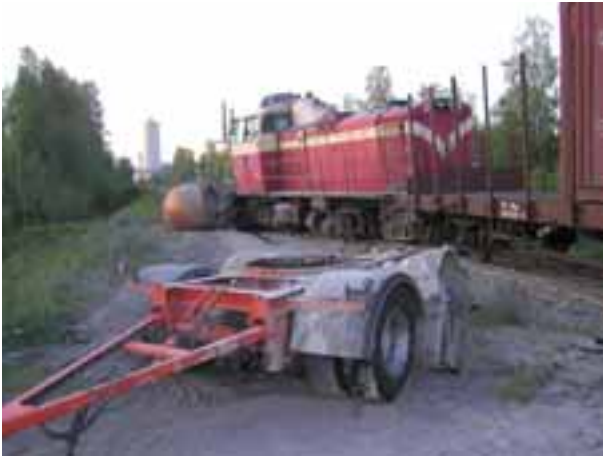
C 6/2003 R

Shunting unit and vehicle combination carrying a cement load colliding in Lappeenranta on 1 July, 2003

On Tuesday July 1st, 2003, an accident took place in Lappeenranta, Finland, when a shunting unit collided with a vehicle combination travelling on a level crossing. In the accident four persons were slightly injured. The locomotive of the shunting unit derailed. As a result of the accident, the trailer of the vehicle combination, a Dv12 dieselhydraulic locomotive and safety installations in the track were damaged. Moreover, the rubber deck of the level crossing suffered some damage. The resulting total cost amounted to about € 150 300.

The accident was caused by the vehicle combination having insufficient time at its disposal for passing the level crossing before the arrival of the shunting unit at the crossing. The visual clearance at the level crossing does not always ensure its safe crossing. As a contributory factor to the accident, within the level crossing area the attention of the driver of the vehicle combination was partly focussed on his mobile phone.

With consideration of the accident, the Accident Investigation Board of Finland recommends that the level crossing referred to be equipped with warning devices. The Accident Investigation Board moreover recommends that such level crossings without safety installations, featuring a poor visual clearance that cannot ensure vehicle combinations a safe crossing, be equipped with a driving prohibition sign applicable to regular vehicle combination traffic.

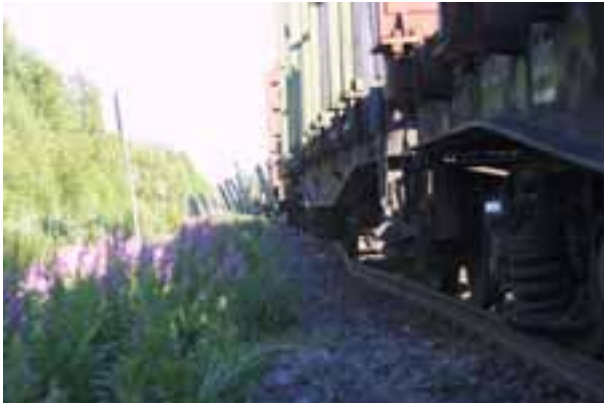
C 7/2003 R

Fourteen Russian freight cars derailling on the section between Hammaslahti and Tikkala on 16 July, 2003

On Wednesday July 16, 2003 at 15.48 hours, a train accident took place on the section between Hammaslahti and Tikkala in Finland: 14 freight cars of a train travelling from Uimaharju toward Niirala derailed. The derailed cars were in the middle of the train, the first one being the 24th car from the locomotive. At the time of the incident the train was running at a speed of 73km/h. No personal injury was generated in the incident, but thirteen Russian timber-carrying cars were damaged as well as ten electric-railway poles and about 400 meters of track. Moreover at the site of the incident, the wooden planking of a level crossing with a farm road was entirely destroyed.

The immediate cause of the incident included the important stress generated in the track as a result of hot weather conditions, and the subsequent heat curve. The relevant incident investigation conducted was unable to specify a particular technical cause for the incapacity of the track structures to endure the generated stress. Actually the relatively advanced age of the track between Hammaslahti and Tikkala and its partly poor condition undoubtedly contributed to the discharging of the stress so as to form a heat curve. The track runs on soft marshland, and its maintenance has therefore proven to be particularly difficult. In this specific case, some railway officials detected the transition that had preceded the heat curve. Unfortunately in spite of the efforts of the engine drivers and the remote control operators, no adequate measures were engaged so as to prevent the incident.

Consequently the Accident Investigation Board of Finland recommends that in view of a prevention of such incidents, the condition of the section between Hammaslahti and Tikkala be improved by implementation of its overall reconstruction or by an adoption and realization of a new track lay-out. In addition, certain improvements in the drawing up of notices of railway technical defects are also recommended to be adopted.

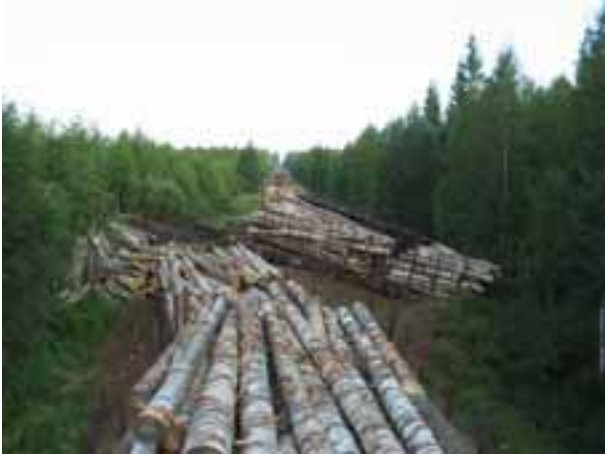
C 9/2003 R

Nine loaded timber-carrying wagons derailed at Rantasalmi on 31 July, 2003

On Thursday July 31, 2003, an incident took place at Rantasalmi where nine wagons of a freight train derailed. In the incident, the nine derailed wagons were damaged as well as about 200 m of track.

The direct cause of the wagon derailment incident was a heat curve having been generated in the track. The heat curve again was a result of the high temperature of the track combined with the poor condition of the rail fastenings and the sleeper bed, as well as the dislocation of rail joints. In addition, the sleeper replacement work in the track and the on-going tamping operations contributed to the vulnerability of the track.

In order to prevent corresponding incidents in the future, the Accident Investigation Board of Finland reiterates its recommendation S181 issued as a result of an accident having taken place at Huutokoski, Finland, on May 31, 2002. The track should immediately be repaired and the defective old sleepers be replaced by new ones. Replacement of spike fastening by screw fastening, replacement of the rails by heavier ones, and replacement of the gravel in the railway bed by ballast should be discussed and considered.

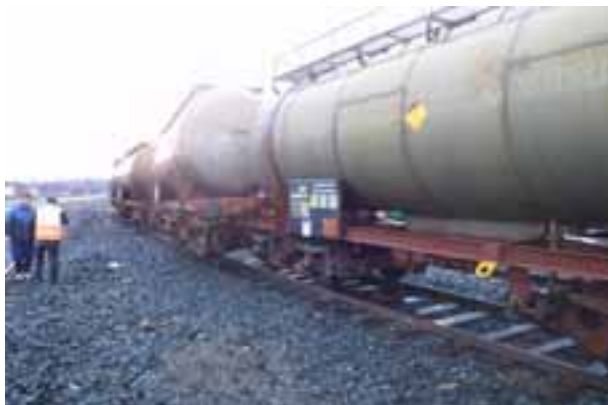
C 10/2003 R

Shunting unit colliding with wagons designed for the transport of dangerous goods on Kemi railway yard on 14 November, 2003

On Friday November 14, 2003 on Kemi railway yard, an incident took place where three empty sodium chlorate wagons and seven loaded cellulose carrying wagons pushed by a shunting locomotive, bumped into loaded sodium chlorate wagons that were at stand-still on the track. As a result of the incident, three wagons derailed. The damage generated by the collision corresponded to about €17,000.

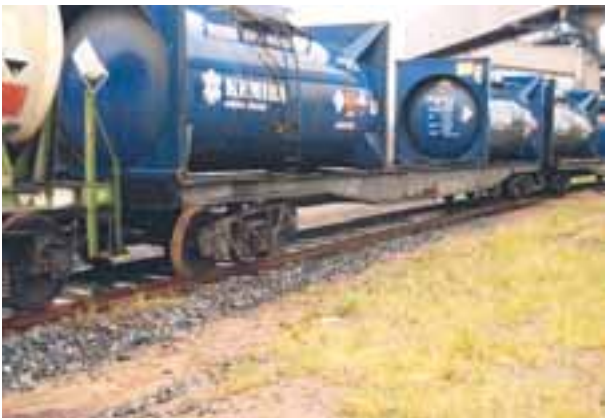
C 6/2004 R

Two Russian container wagons loaded with sulphur dioxide carrying containers derailed at Harjavalta on 7 June, 2004

The derailment was caused by the poor condition of the track. Important lateral pegs, that is, rail joint wear had been generated in the steep curve. Moreover, the insufficient tamping of the track and the probably non-bent rails used in the curve contributed to its poor condition.

In order to prevent corresponding incidents in the future, the Accident Investigation Board of Finland recommends that the company responsible for the maintenance of the track in question draw up a maintenance plan for the railway lay-out specifying the regular maintenance operations to be implemented for the railway lay-out.

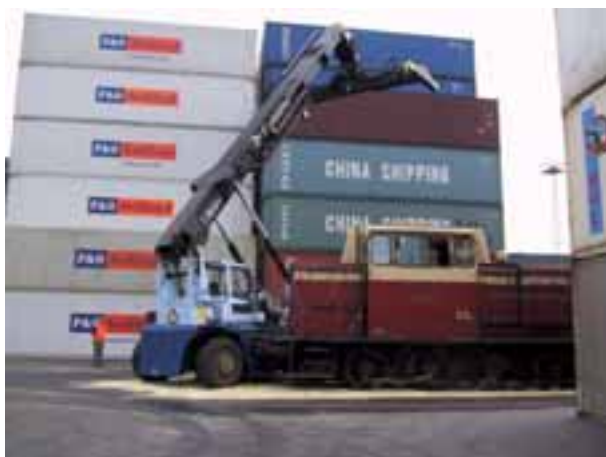
C 8/2004 R

Shunting unit and reach truck colliding in Helsinki West Port on 29 June, 2004

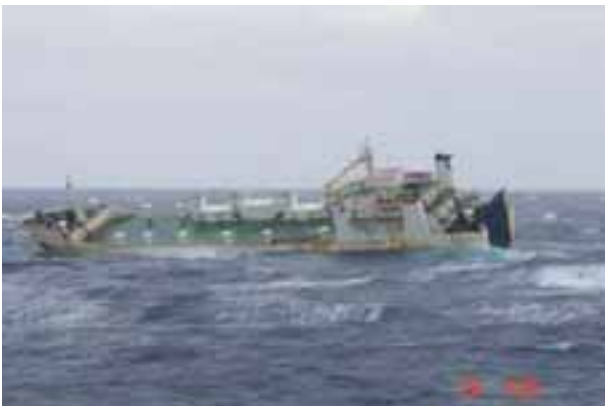
B 1/2003 M

ms CAMILLA, serious incident in North Atlantic on 23 January, 2003

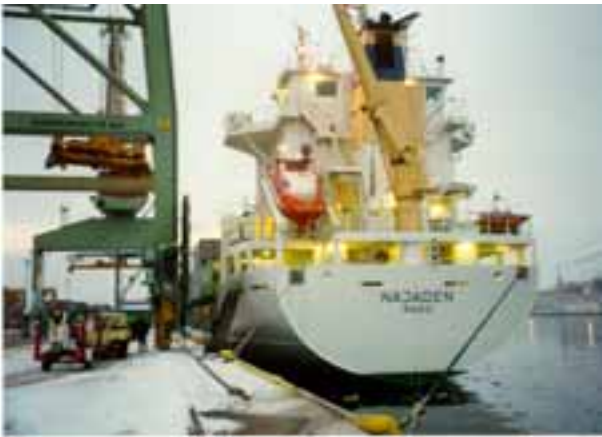
C 8/1997 M

ms NAJADEN, grounding off Estonian coast on 12 July, 1997

In summer 1997, bound from Kotka, Finland for Hamburg, Germany a Finnish Feeder-class cargo vessel grounded on 12.7.1997 off Estonian coast. The officer on watch had fallen asleep soon after he took the watch. He had not altered the course to follow the traffic separation but the vessel carried on across the Gulf of Finland over three hours until she grounded. The bottom of the vessel was damaged. Those onboard were not hurt and no environmental harm was caused.

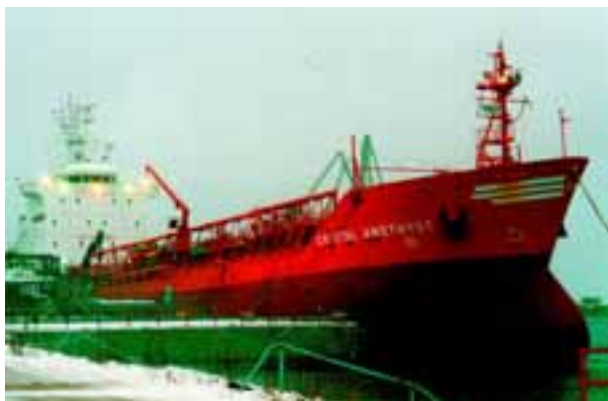
C 16/1997 M

mt CRYSTAL AMETHYST, grounding off Mussalo Harbour in Kotka on 1 December, 1997

Master concentrated on steering and adjusting the propeller pitch. The pilot gave steering commands using rudder angles. Pilot's reference of position was a green buoy, which he assumed to be the northerly one of two buoys. The chief mate came on the bridge at 18:09 and took the helm. At 18:10 CRYSTAL AMETHYST ran aground at Matinmatala. The pilot's reference of position had been the buoy in north westerly direction instead of the assumed one in northerly direction.

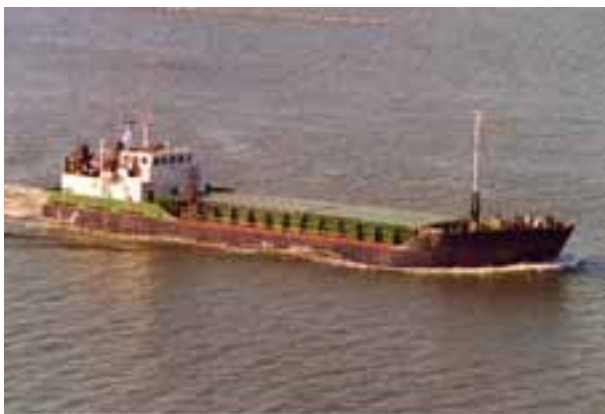
C 7/1998 M

Motor vessel PAMELA, grounding in the Finnish archipelago on 3 August, 1998

Finnish motor vessel PAMELA ran aground in Stångskär en route from Korppoo to Olkiluoto on 3.8.1998. The master was acting as the officer on watch as he fell asleep. The vessel got damages to her bottom plating. No environmental harm occurred.

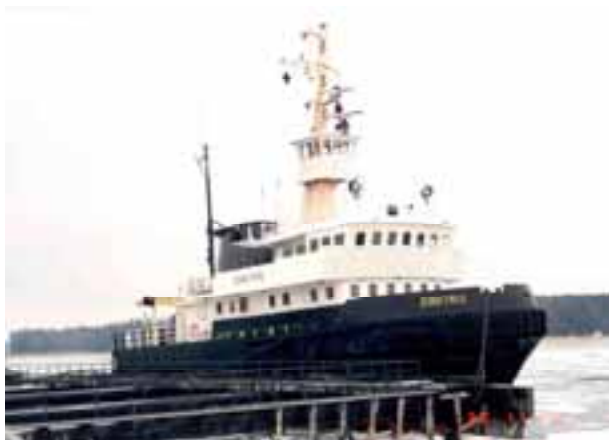
C 10/1998 M

Tugboat DIMITRIS, grounding off Inkoo on 29 November, 1998

Tugboat DIMITRIS and the towed barge MULTIBRAVA, with coal cargo, was on her way from Vysotski Russia to Inkoo Finland on 29.11.1998. The pilot boarded the tugboat at the Porkkala pilot embarking position at 00:05 am. The prevailing weather conditions were unstable. The weather forecast had predicted the conditions: moderate visibility and possible snow fall. Visibility went down to 0,5 Nm - 0,7Nm. The tow proceeded on the Inkoo fairway until the next buoys 7 and 8 were abeam. For some reason the wrong 3.7 meter fairway towards Gåsö was followed. The mistake was observed after about half an hour and a few minutes before the tugboat run aground. The aft anchor from the barge MULTIBRAVA was let go to slow down the speed. DIMITRIS also slowed down. After some five minutes the grounding of the tugboat was felt on board. The barge passed the tugboat on the port side and broke the towing cable. The position of the grounding/DIMITRIS was south of the Gåsöklobben. The barge MULTIBRAVA was anchored west of Gåsöklobben. Personnel injuries and environmental damages were avoided in this accident.

During the investigation it was found out that the steering along the wrong fairway was not observed in time because safeguards were missing from the navigation. Not all the navigational aids nor the fairway knowledge were used with sufficient rigorousness. The communication and exchange of information formed a problem on the bridge. Previous safety recommendations have been issued on those and have been referenced by the investigators.

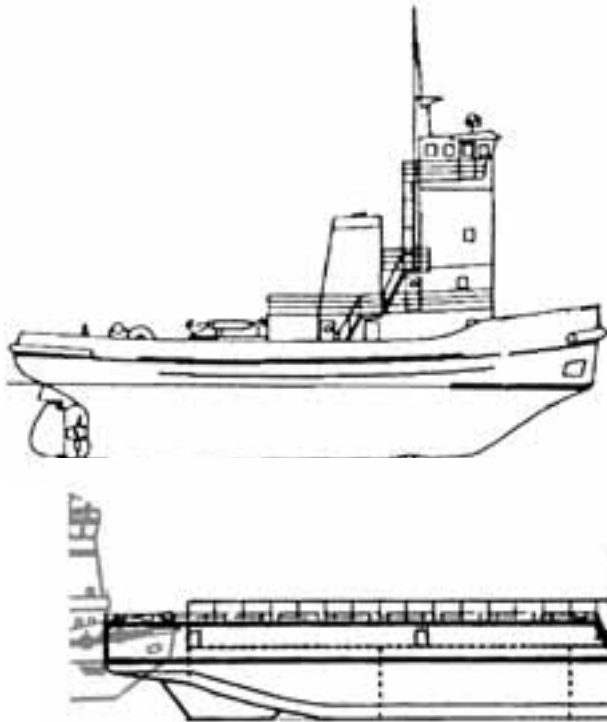
C 4/2001 M

The pusher-barge combination ALFA / PARA-UNO collision with the freighter SORMOVSKIY 118 within a separation zone in Northern Baltic on 15 May, 2001

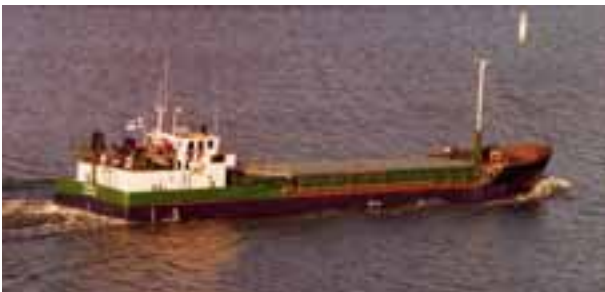
C 10/2001 M

ms PAMELA, grounding in Kihti on 2 October, 2001

The damage control took place preliminary in nearby area and later in the port of Naantali with the attendance of classification society's representative. The damages were minor and the vessel got a permission to carry on trading.

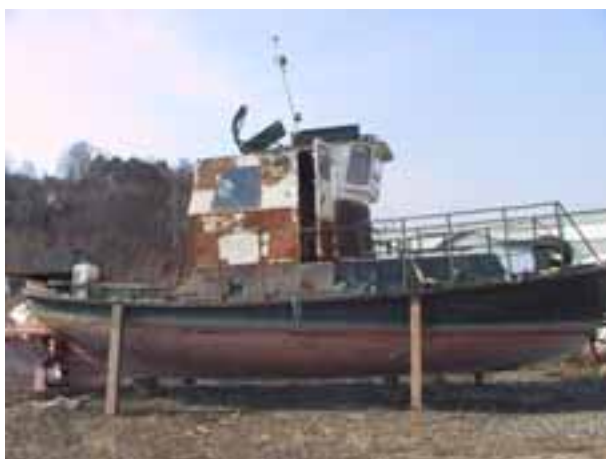
C 11/2001 M

Tug EEVA, sinking on Airisto on 19 October, 2001

Small tug EEVA was pushing a little working pontoon on Airisto in the archipelago sea area near Turku when she suddenly sank in the evening at about 21 hours between the isles Vepsä and Rymättylä. To the Master's surprise the tug had taken so much water. He could not prevent sinking with the inadequately working pumps available. While the Master tried to pump water out the tug drifted about one nautical mile southwards. During the drifting the Master did not make emergency call. When the tug had sunk the Master succeeded to climb on the working pontoon after which he tried several times to make the emergency call by his mobile phone until he succeeded on third time at 22:12. The Master had been on the pontoon for about an hour and half before the SAR units arrived to the scene. He was rescued by the patrol boat of police half an hour after the emergency call.

The tug was salvaged and inspected after the accident. The sealant of the propeller tube was missing. The sinking of the vessel was assumed to have started with the leak through the propeller tube. The sinking was, in addition to the leak, due to an initial heel caused by the shifted deck cargo and the water in the hold. After heeling the aft cargo hold was filled by water by the

waves through the hatch opening. The investigator presents no safety recommendations, but highlights the importance of good safety attitudes and practises as well as preparedness for accidents.

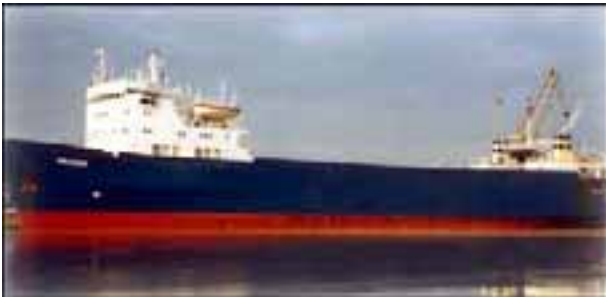
C 13/2001 M

ms TRADEN, incident caused by cargo shift in the Atlantic on 19 October, 2001

The cargo shift took place in stormy Atlantic after passing Portugal, when containers on weather deck and Pendolino railway carriages on main deck came loose from their lashings. The containers came loose when fastenings on the deck broke, and the railway carriages shifted because trestles below them had collapsed.

Containers on the weather deck were fastened to D-rings, which were too weak. The D-rings had become thinner but did not break, whereas welding junctures of D-ring fastenings were torn. After the emergency the D-rings have been replaced with new ones, and fastenings have been made clearly stronger than the broken ones.

Loosening of the Pendolino railway carriages was a consequence of the manner to fasten the trestles to the deck. There were degrees of freedom for motions / free unfastened motion directions without fastenings at all, and therefore the loose trestles’ legs were able to move and the trestles collapsed.

The ship was relatively lightly loaded and this was compensated with ballast. The draught was, however, quite small in the current loading condition, and the ship was very stable, which increased loads acting on cargo. Bilge keels have been removed during previous docking because of ice damage, which also increased roll motion and loads on cargo.

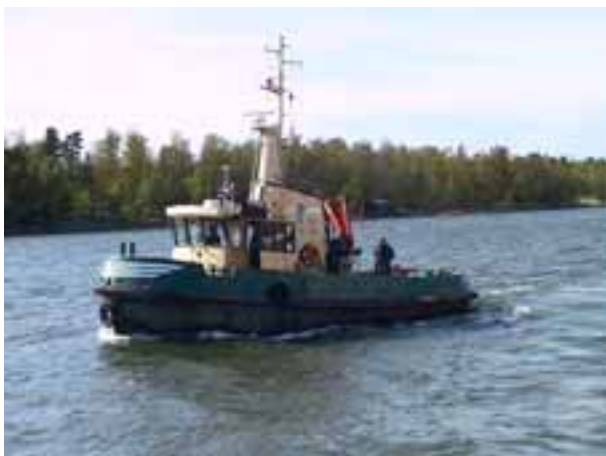
C 14/2001 M

Tug boat VOIMA, sinking in port of Kaskinen on 21 November, 2001

and mate found themselves in the sea. VOIMA finally sunk at 21:08 hours when the tow line was cut onboard PIONER KARELII.

The main cause of the accident was the fact that the tug boat was not suitable for assisting in this dangerous way pulling opposite to the vessel in assistance having too much speed ahead. There was a lack of communication between the two vessels specially concerning the engine commands. The tug boat's stability did not fulfil the requirements and the crew was inexperienced in harbour assistance. The tug boat capsized and sunk quickly because the engine skyllet was open.

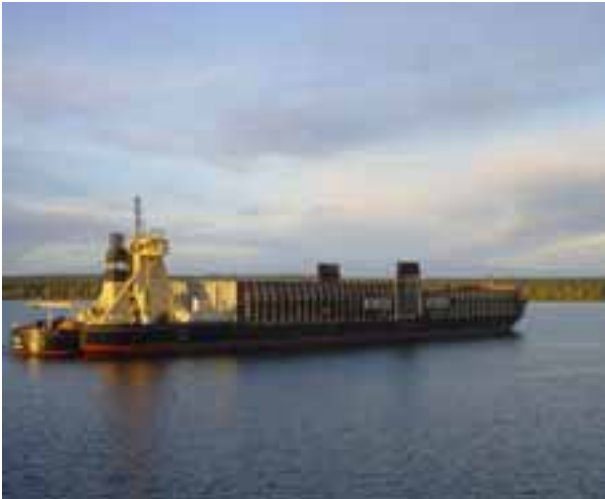
C 4/2002 M

Pusher barge combination ms STEEL-BOARD, grounding at the Kvarken on 1 January, 2002

The pusher barge combination STEEL-BOARD grounded on January 1, 2002 at the Kvarken en route from Vysotskij, Russia to Raahe, Finland. The chief officer being the Officer On Watch had fallen asleep and did not conduct the course change according the route plan in Nordvalen. He was alone in the bridge because he had relieved the look out to other work onboard. The investigation tried to find out the factors, which can be identified to cause such performance impairment that led the OOW make his decision to work alone and why he fell asleep. The investigators do not make any recommendations on this case. AIB Finland will later publish a safety study on numerous accidents at sea in which the main contributing factor has been the fatigue of the OOW.

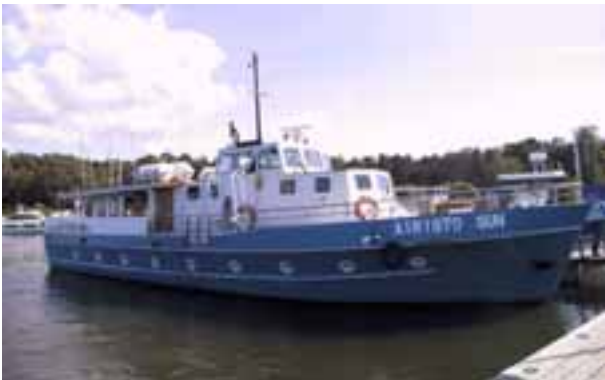
C 8/2002 M

Passenger vessel AIRISTO SUN, danger situation outside the port of Rauma on 28 July, 2002

The passenger vessel M/S AIRISTO SUN got into a danger situation outside the port of Rauma while transporting the passengers to the tourist destinations according to the time table. The journey began from Syväraumanlahti to Kuuskajaskari at 18.15 in 28.7.2004 and no troubles were found during the first 15 minutes. Then the indicator of cooling water temperature in the engine began to alarm. Master stopped the engine according to the advice given on the phone by the ship-owner. Then he called via VHF-radiotelephone the coast guard station in Rauma at 18.35 o'clock. Master estimated that the vessel would probably drift in ten minutes aground and he told it to the coast guard patrol, and he had a wish that the patrol could get in time to give assistance.

By using the maximum speed the patrol came on scene at the same time when AIRISTO SUN hit aground the first time. The patrol boat began to tug AIRISTO SUN at 18.55. After 15 minutes tugging M/S AIRISTO STAR, another passenger vessel of the shipping company, came alongside AIRISTO SUN and the passengers proceeded via gangway from the damaged ship to the whole ship. They didn't have any lifejackets on.

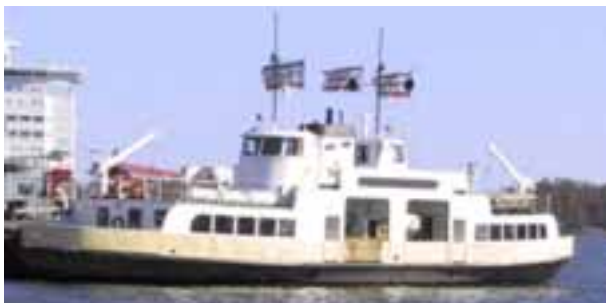
C 10/2002 M

Passenger ferry ms SUOMENLINNA-SVEABORG, collision with quay in Helsinki on 31 August, 2002

Altogether 12 persons needed first-aid or hospital treatment. The two most severely injured passengers had descended the stairs and fallen down due to the force of the collision. The vessel received minor damage.

The immediate cause of the collision was established to have been a shortcut in the leads of the lighting of the pitch control display. The shortcut for its part caused a relay in the control system not to function. The chafing and temporary contact had been a consequence of the vibrations of the vessel.

As contributing factors were observed problems related to the pitch control retrofit carried out in 1995 on the vessel, which originally had been built in 1952. The ship owner actions on the recurring faults was found to be inadequate.

As safety recommendations it has been released that both the ship owner and the Finnish Maritime Administration should improve their roles so that the safety management system would better remedy the observed technical faults and deficiencies in operational practises.

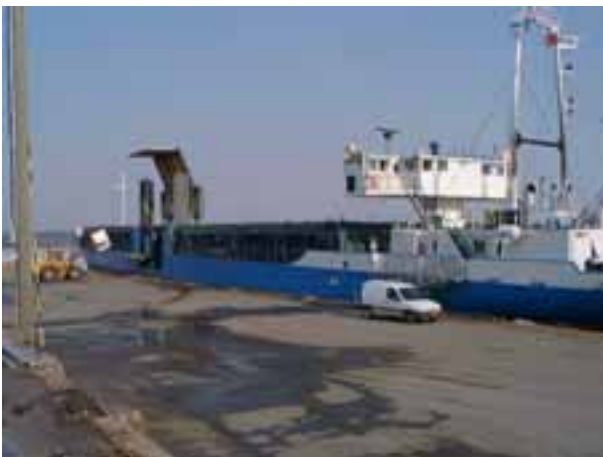
C 13/2002 M

ms KAJEN, grounding in Ruotsinsalmi, off Port of Kotka on 18 March, 2002

KAJEN run aground on March 18, 2002 at 01:30 when turning into the Ruotsinsalmi fairway. The primary cause of the accident was the ice condition. Fast ice floes had drifted to the fairway and ice floes had frozen together. When the vessel was turning into the fairway she steered strongly out of the fairway while hitting the ice floes. The turn could not be controlled with opposite helm and it was too late to stop her. KAJEN run aground at very slow speed with engines full astern.

The accident revealed deficiencies with the working habits between the pilot and the officers. This repeats from accident to accident. The unofficial working habits have a silent approval of seafarers, authority and ship owners. According to the opinion of the accident investigation the current customary working practices have diverged from the aim of the regulations.

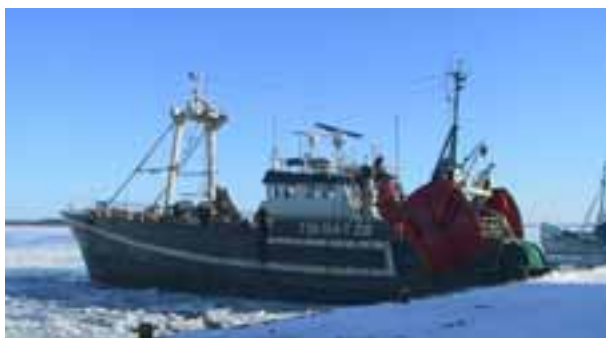
C 1/2003 M

Trawler BRIAN KENT, incident at an ice floe off Pori on 5 February, 2003

On 5.2.2003, a steel trawler BRIAN KENT from Pori, Finland, crashed into an ice floe at a distance of about 35 nautical miles northwest of Reposaari. As a result of the incident, the bow of the trawler was damaged and the collision bulkhead behind the fore peak retracted and partly came loose from the coaming. The fore peak and the fore hold behind the collision bulkhead were entirely covered by water.

The corresponding investigation conducted disclosed that the frames in the fore peak of BRIAN KENT failed to be appropriately fixed in the keel. In fact some frames ended at a distance of several hundreds of millimetres before the keel. As a result, the bow construction was weak.

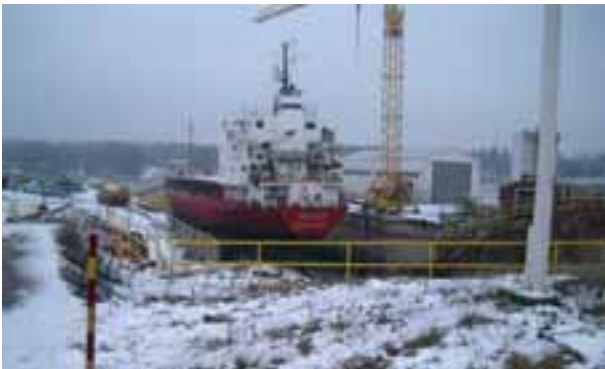
**C 3/2003 M**

ms BIANCA, grounding off Gävle in Sjalstenarna shallows on 31 March, 2003

The general cargo vessel BIANCA run aground on March 31, 2003 at 0504 hours. The grounding took place in the Swedish territorial waters north of the Gävle fairway in the Sjalstenarna shallows. BIANCA hit the ground in to the eastern end of the shallow with heading 287 degrees. She got damages to her hull, leakages to bottom tanks as well a serious one in to the engine room.

The fatigue of the OOW and his falling asleep follows the same scheme as numerous other groundings of Finnish cargo vessels during the last years. In all these as well as in the BIANCA case the contributing factor has been the lack of rest and lack of management of the bridge teamwork, i.e. the look out is not used effectively. The breaking of ones circadian rhythm makes it difficult to stay awake during the late night and early morning hours. This was the case also with BIANCA's grounding.

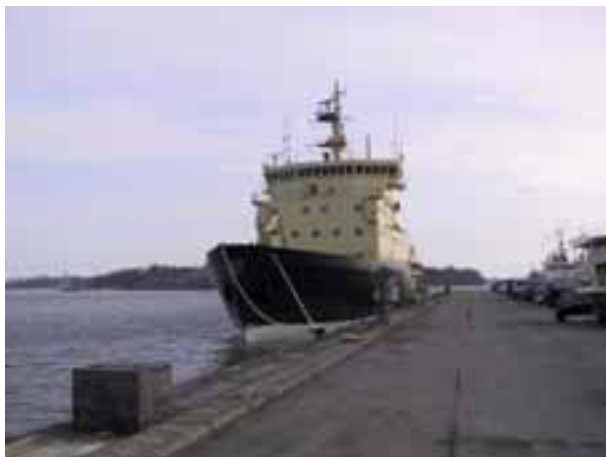
C 4/2003 M

Icebreaker VOIMA, grounding off Helsinki on 11 April, 2003

After TANJA had got fastened in the ice VOIMA continued her way towards the ships laying in the ice a few miles southwest. Helsinki VTS warned VOIMA about TANJA's close position to the Ulkomatala shallow and later about her drift towards it. After having interrupted the assistance of the vessels further, VOIMA returned to assist TANJA. During these assisting attempts TANJA had drifted north-west among the drifting ice closer to Ulkomatala. When taking TANJA into tow, which took longer than anticipated, the icebreaker grounded 11th April 2003 at 04:50 o'clock. No leaks were observed.

The contributing factors to the accident were found to be the vague and jammed traffic situation, the poor co-operation of the bridge team caused by large amount of radio traffic and the lack of guidelines for the co-operation between the organisations supporting the icebreaker assistance. Other safety observations concern the possible fatigue, the organisational changes in the Finnish Maritime Administration and the effect of the exemptions from traffic limitations.

The safety recommendations issued by the investigation team deal with the guidelines for co-operation within the administration concerning winter navigation and icebreaker operation and the training of the bridge teams in the equipment familiarisation.

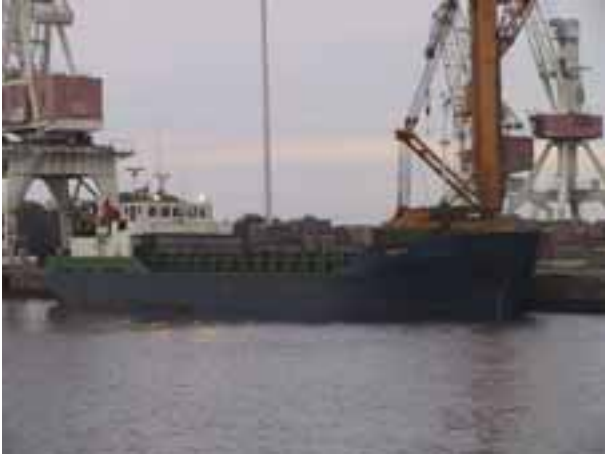
C 6/2003 M

ms PAMELA, grounding south of Södertälje in Sweden on 23 April, 2003

The Finnish coaster ms. PAMELA run aground at 02.27 hours on April 23, 2003 south of Södertälje, Sweden. She got leakages in her fore peak. There were no other damages. As the fore-peak leaked empty, PAMELA re floated without assistance. After a thorough inspection the maritime inspectorate gave permission to tow her to Stockholm for repair. It was found out that the watch keeping arrangements were not according the normal practice. Fatigue was found to be one of the contributing factors leading to this accident.

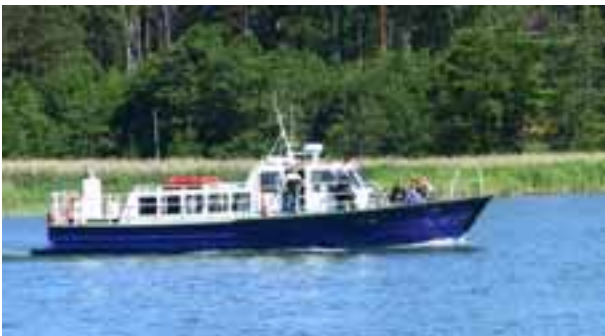
C 7/2003 M

Water bus KAROLINA, grounding and engine failure in Houtskär archipelago on 14 June, 2003

KAROLINA was on her way from Näsby, Houtskär to Äpplö island, when at 3:40 p.m. she grounded on a islet at Ramsö area. The vessel upsurged on to the rocky islet. The master made attempts to re float her by using the main engine without success. With his mobile phone master called a local taxi boat to assist him. When the attempt with taxi boat's help was found unsuccessful the local fire brigade was called on site. The fire brigade patrol boat towed KAROLINA off the islet and the master continued his trip after making a visual inspection for possible leaks.

ceeded from Näsby to Bockholm. When passing Kalvholm an alarm signal sounded and soon after this the engine stopped and did not start again. The vessel was anchored and the master called with his mobile phone the fire brigade patrol boat. KAROLINA was towed to Roslax pier and the passengers arranged their travel to their home islands by themselves.

There were no personal injuries and the damages to the vessels hull were minor. The engine was a total loss and had to be replaced by a new one.

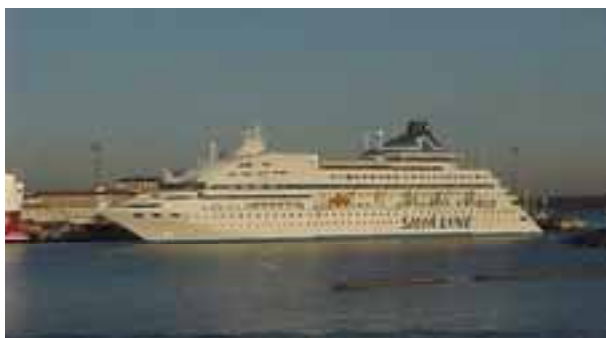
C 8/2003 M

ms SILJA OPERA, collision with three cargo liners in St. Petersburg harbour on 17 September, 2003

As specified in the investigation report of Sjöfartsinspektion, the accident was caused, e.g. by the following circumstances:

1. The position and the movements of the vessel failed to be carefully monitored by the pilot and the navigation bridge crew.
2. Poor communication between the bridge crew and the pilot.
3. Current of the canal, bottom suction, and the wind pressed the vessel laterally.

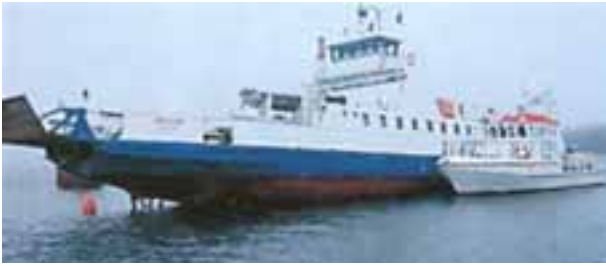
C 9/2003 M

**Archipelago ro-ro passenger vessel
SPOVEN, groundings off Torsholma and
near Degerö on 7 and 8 November, 2003**

The Åland archipelago ro-ro passenger vessel SPOVEN ran aground on her voyage from Lilla Hummelholm to Lappoo on November 7, 2003 at 17:45 hours. She ran aground again on November 8, 2003 at 14:40 hours west of Degerby. She got damaged in the second grounding and had to be towed to a dry dock in Mariehamn. The causes of the groundings were poor visibility and the routines in navigation. In the later grounding a contributing factor was fatigue. The master had been up and awake continuously 32 hours before the grounding.

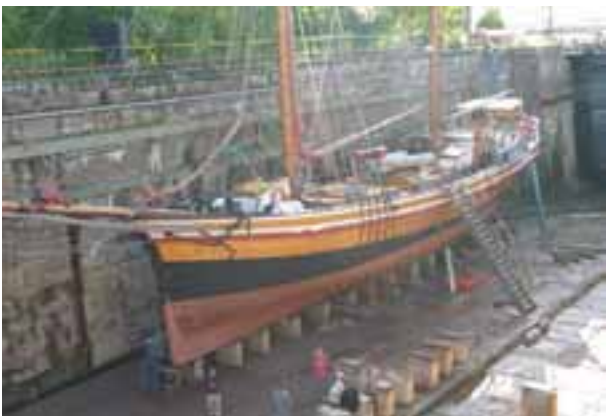
C 6/2004 M

Ketch VALBORG, grounding in Porvoo archipelago on 4 August, 2004

The ketch VALBORG sailed on August 4, 2004 at 12.45 hours from Pirttisaari in Porvoo archipelago to Stora Brokholm. Onboard there were the crew of four and a group of young people in preparation for confirmation. As the master was turning the vessel from Hummelkobba line to northwest to the Ygglasö stern line, the vessel got north of the fairway and grounded at 20.45. Two blanks in the stem loosened and she got a leakage. The situation was kept under control by pumping and VALBORG was able to sail to Tirmo where she was berthed. After diver's inspection VALBORG moved to Helsinki with her own machinery and was taken to dry dock for reparation on August 16, 2004. The basic reason of the grounding was the lack of route planning beforehand. The curve was too gentle and it was not finalized as the vessel reached the narrow part of the fairway guarded by spar-buoys. At the same time the master was dazzled by the sunshine from west. As a contributing factor the investigators found the common habit to corner cut the routes marked in charts. This kind of habit has been found in numerous cases investigated by AIB.

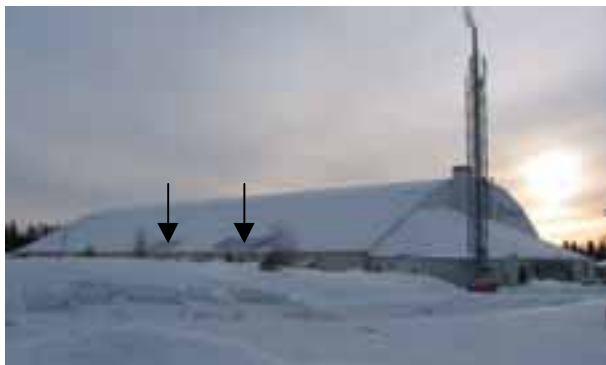
B 1/2003 Y

Roof of multi-purpose hall collapsing at Mustasaari on 17 January, 2003

Furthermore, the relevant investigation disclosed shortcomings in the calculations of the loads to be endured by the beam lattices mounted between the girders, in the dimensioning of the structural components connected in the damaged joint, and in the overall bracing of the hall. These secondary shortcomings nevertheless had no direct impact on the collapsing of the roof.

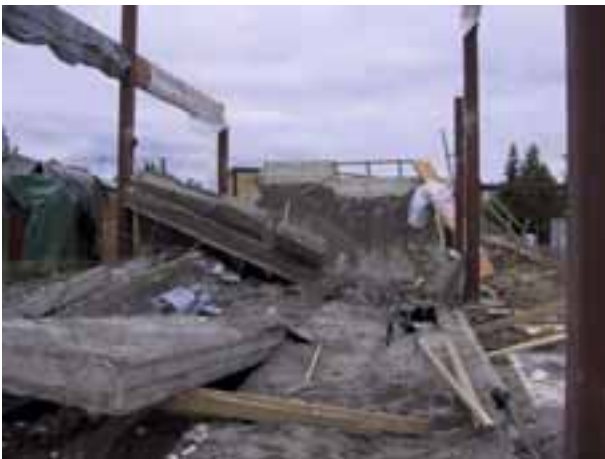
B 3/2003 Y

Fall of an intermediate floor structure intended as permanent at a service station site in Orivesi on 25 August, 2003

The steelwork had been manufactured in a small machine shop, transported to the site, and assembled and installed there. The hollow-core slab section with its horizontal steel beams fell when three of the six consoles supporting the horizontal beams and hollow-core slabs came off the pillars. The consoles had been fixed to the pillars with fillet welds, but these failed completely. The welds hardly penetrated the pillar, and the load borne by each joint was only a fraction of its design capacity. Apparently, the technical reason was that the welding voltage used had been slightly too high and the welding torch had been held in a slightly incorrect position.

To avoid similar accidents, the investigation commission recommends that the organisations in the of steel construction branch establish procedures for determining and proving the compliance of welded steel structures in order to aid in the supervision of construction and assist the construction organisation and the manufacturers of structures.

Furthermore, the investigation commission recommends that the construction supervision authority remind the developer during the early stages of a project of his duty of solicitude and of methods of establishing the compliance of products supplied by contractors and subcontractors. In this way, developers would be better prepared to monitor the capability of the construction organisation formed by them to produce structures in compliance with the standards.

In the welding tests performed during the inquiry, it was noted that one proof of a good welded joint is a bright streak left on the edge of the weld. This observation should be studied in more depth, and - as applicable - the subject should be added to the instructions for visual inspection of welded joints.

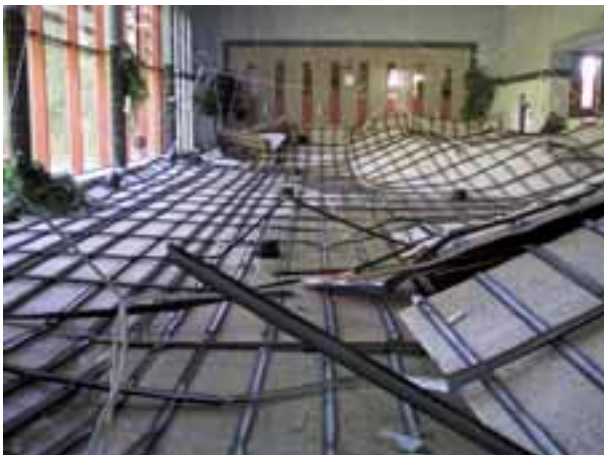
B 4/2003 Y

Dropped ceiling of indoor spa resort collapsing in Kuopio on 4 September, 2003

On Thursday morning September 4, 2003, the dropped ceiling above the main pool in the new pool compartment of Rauhalampi spa-resort hotel in Kuopio, Finland, collapsed in its entirety. At the time of the incident, there were three persons swimming in the pool. At 8.52.48 hours the swimmers perceived that the ceiling was falling down. In two seconds the dropped ceiling had collapsed in the water slide end of the pool, and in three seconds the entire dropped ceiling had fallen down. The swimmers failed to escape from the blow of the collapsed ceiling, but they were located in a way that they managed to avoid losing consciousness by the blow. In fact they man-

The collapse of the dropped ceiling was caused by a breaking of the suspension wires made of stainless steel, as a result of stress corrosion. Some wires close to one another having broken, the stress in the adjacent wires grew to the extent that other wires that had weakened by the stress corrosion, broke and spring suspensions came loose from the supporting long beams. As wire material, AISI 304 stainless steel had been selected, as at the time of the realization of the project, the designers, planners, constructors and building supervision authorities had no knowledge of the SFS-ENV 1993-1-4 Eurocode preliminary standard with its national implementation instructions, and they were hence unable to use it in the selection of an appropriate steel quality for indoor swimming-pool and spa conditions. According to an investigation conducted by the Technical Research Centre of Finland (VTT), the AISI 316 acid resistant steel specified in the original plans would not have been a significantly better solution as regards stress corrosion. Stress corrosion is not only conditioned by stresses caused by load, but a more important conditioning factor is to be seen in the residual stresses generated by wire treatment. In practice residual stresses can hardly be avoided as they are generated even in the installation phase.

The ceiling having been built, the condition of its suspension and supporting structures had not been inspected, as the dropped ceiling featured no inspection hatches and its height from the upper level of the pool was over five meters.

To prevent corresponding collapses of dropped ceilings, the Accident Investigation Board of Finland recommends that the regulations and instructions pertaining to planning and design should include detailed specifications for such important load support construction materials that are appropriate for indoor swimming-pool and spa conditions, in terms of safety. Moreover, the instructions concerning dropped ceiling structures of indoor spa resorts and swimming pools ought to be updated so as to consider dropped ceilings as support constructions and to realize the air-conditioning of the space above the dropped ceiling in a way rendering impossible any chlorine penetration or accumulation on the surfaces of non-corrosion-resistant structures.

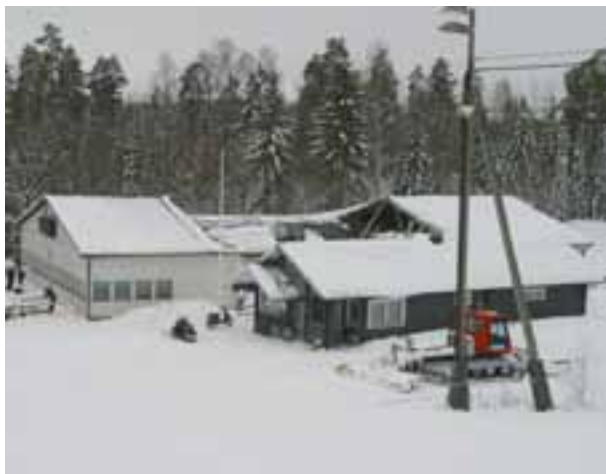
B 1/2004 Y

Collapse of the roof of a maintenance building built by voluntary workers at a slalom centre in the municipality of Pohja on 1 February, 2004

Early in the morning of Sunday 1 February 2004, approximately 250 m² of a maintenance building of 720 m² collapsed at a slalom centre in the Municipality of Pohja. The building housed a cafeteria, ski hire business, machinery shelter and an open space for victory ceremonies, karaoke events etc. and functioning as a lounge. At the time of the accident, the slalom centre was closed, although staff engaged in preparations for the day's competition had already arrived. However, no one was injured and there was only slight material damage.

The technical cause of the accident was a flexural moment, significantly higher than the capacity of the rafters and which was exerted on the rafters near the ridge. This could have been avoided by designing the truss diagonals to extend all the way up to the ridge, whereas in the actual truss, the diagonals extended along the rafters, but stopped 1.5 metres short of the ridge. The trusses were therefore poorly dimensioned, and the flexural moment and other force values for the rafters incorrectly calculated.

The slalom centre is owned by a local sports club, and the maintenance building was designed and built by voluntary workers in 1993 and 1994. In the opinion of the Board of Inquiry, the structural deficiencies were caused by the construction organisation's lack of experience.

For existing buildings of this type, the Board of Inquiry recommends that municipalities, local building officials and building owners establish whether buildings exist within their areas whose structural safety should be examined. If their structural safety cannot be established based on the designs and other material, additional studies and reinforcement of the structures may be necessary.
